Appendix C

Photograph Log

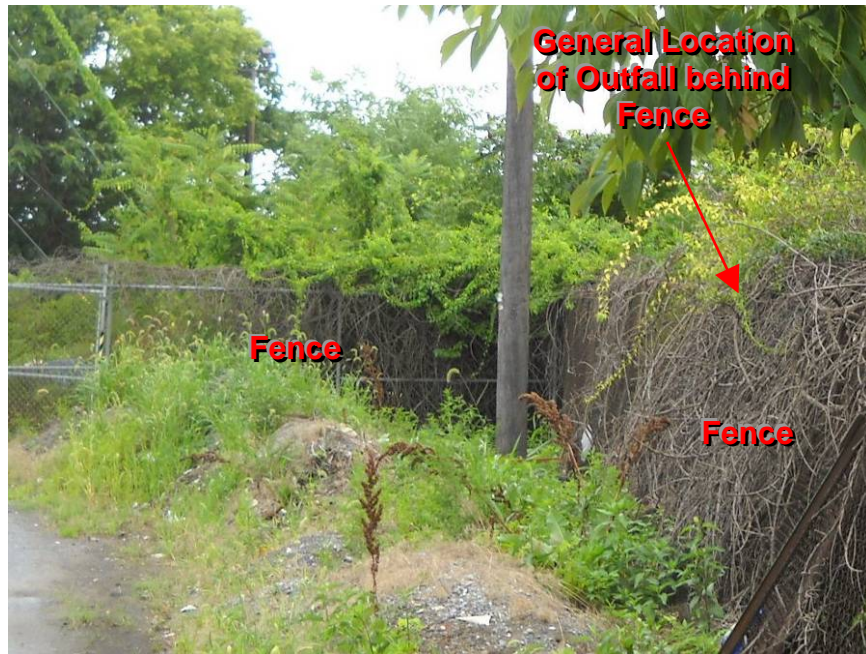
Photograph 1. Outfall Observation Location #1 – MS4 outfall is located behind pictured fence in a densely vegetated area.

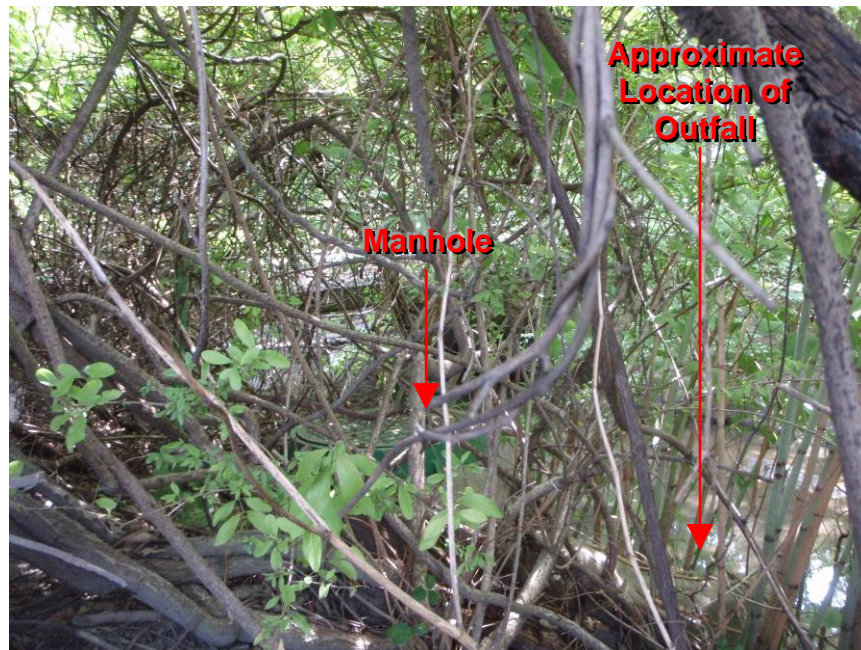
Photograph 2. Outfall Observation Location #1 – View through fence and vegetation shown in Photograph 1 to approximate location of MS4 outfall.

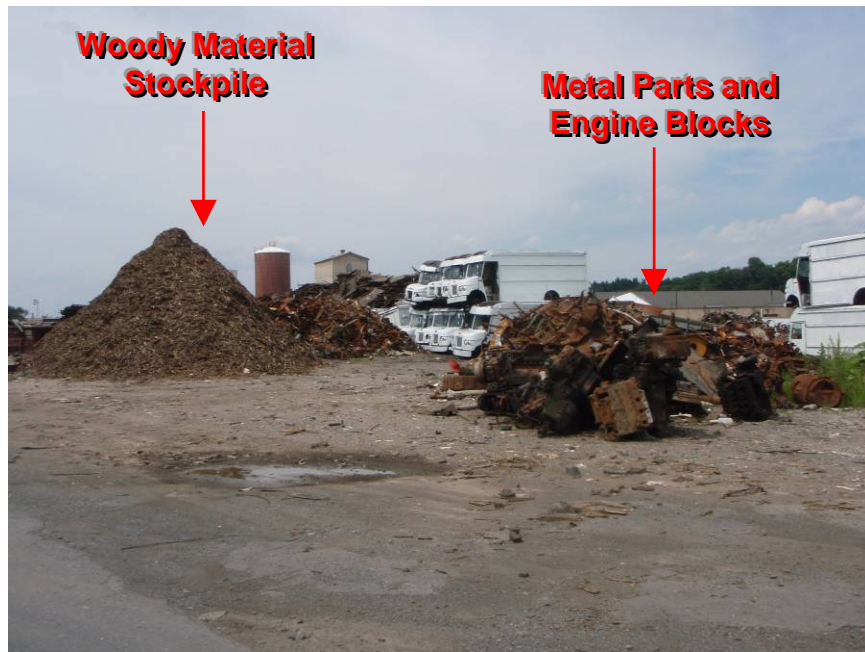
Photograph 3. Outfall Observation Location #1 – Stockpiled materials stored without cover or containment in upgradient area about 50-75 feet from Paxton Creek.

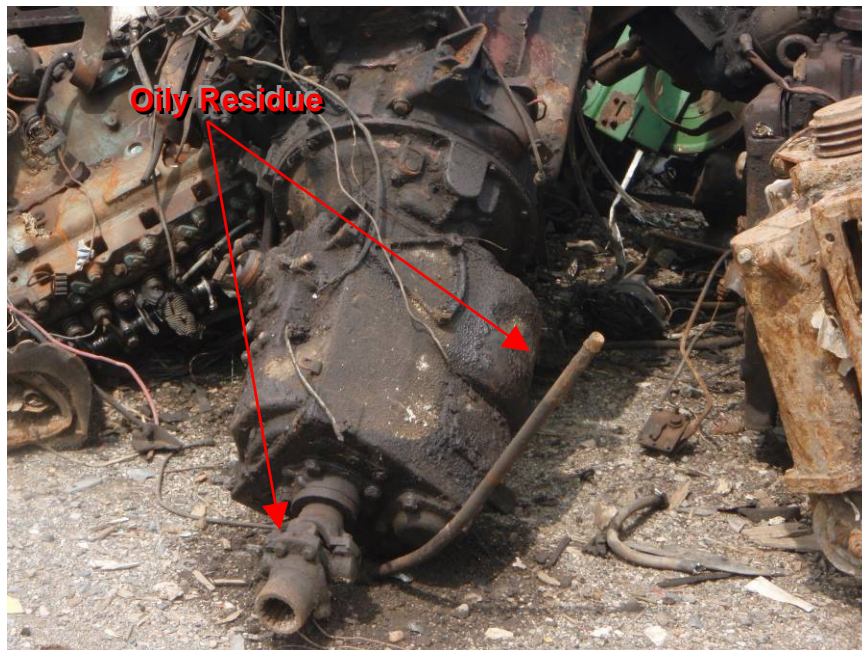
Photograph 4. Outfall Observation Location #1 – Close-up of metal parts and engine blocks shown in Photograph 3.

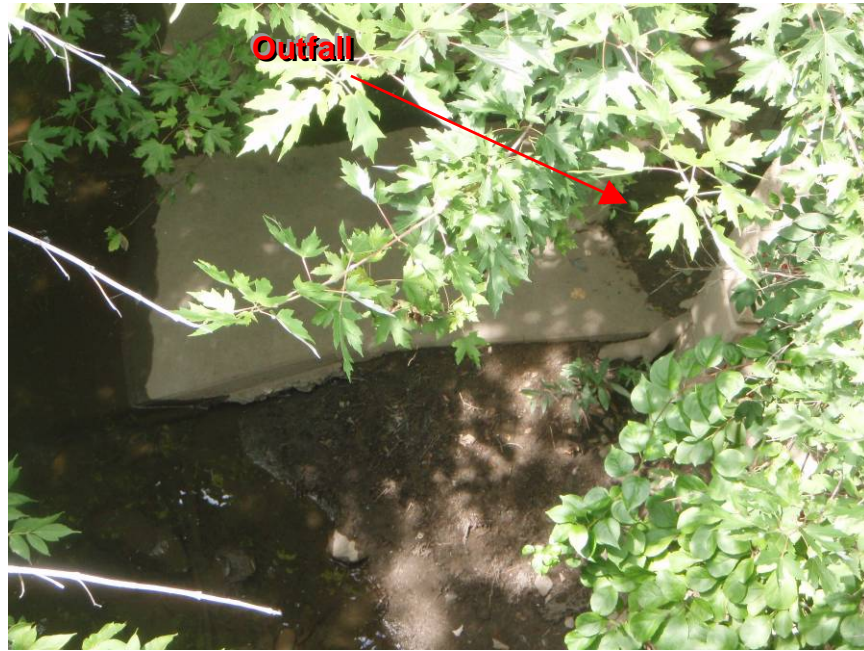
Photograph 5. Outfall Observation Location #2 – View of MS4 outfall on north side of bridge adjacent to Turbine Airfoil Designs, Inc.

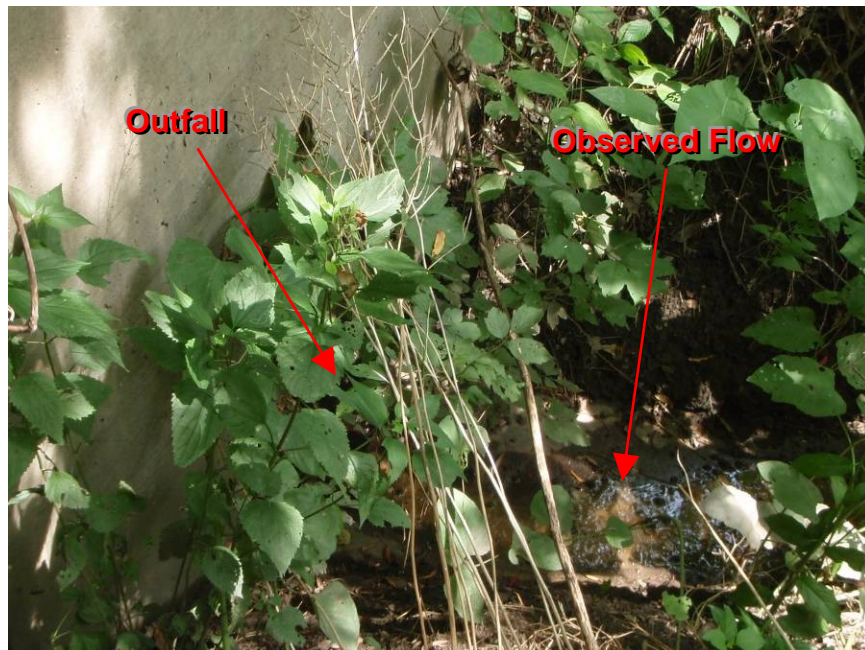
Photograph 6. Outfall Observation Location #2 – View of MS4 outfall on south side of adjacent bridge. Note small volume of observed flow.

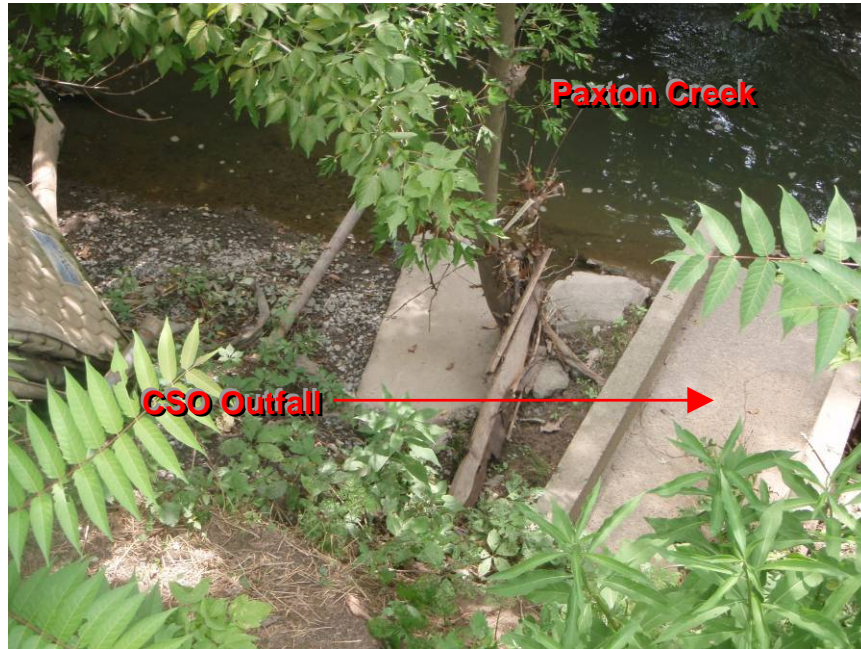
Photograph 7. Outfall Observation Location #2 – CSO outfall to Paxton Creek from CSO 023.

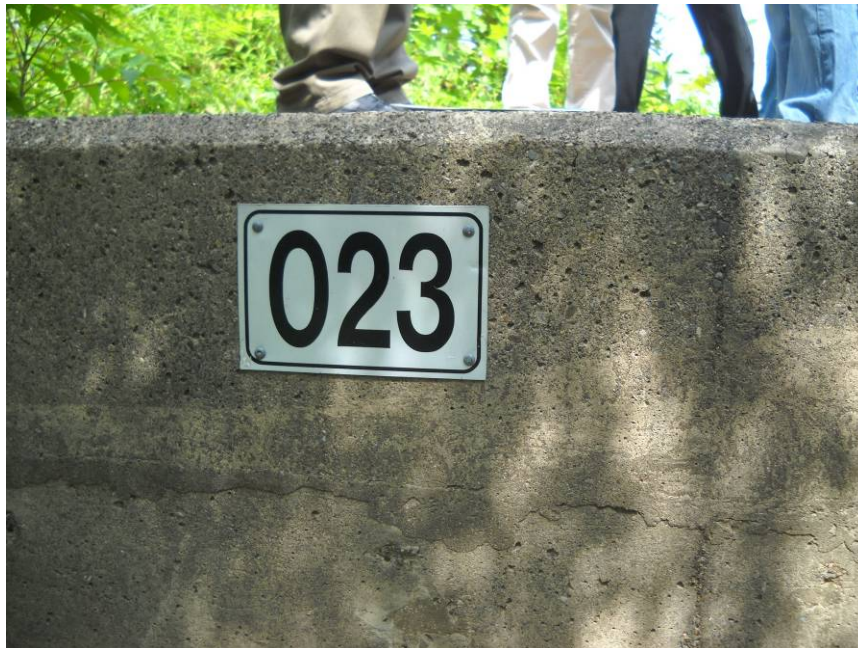
Photograph 8. Outfall Observation Location #2 – Close-up view of sign for CSO 023.

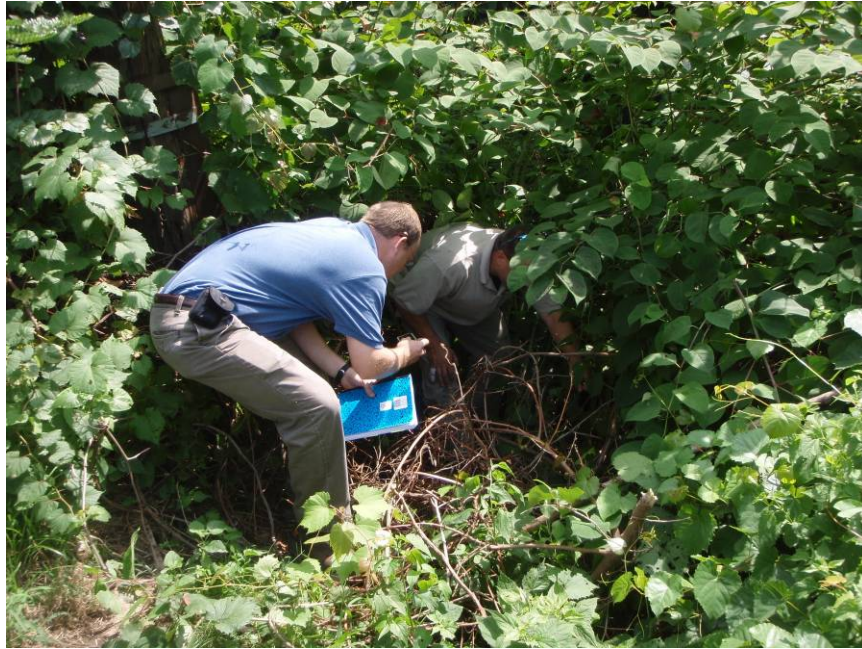
Photograph 9. Outfall Observation Location #3 – EPA Inspection Team members searching for an MS4 outfall at west end of Cumberland Street.

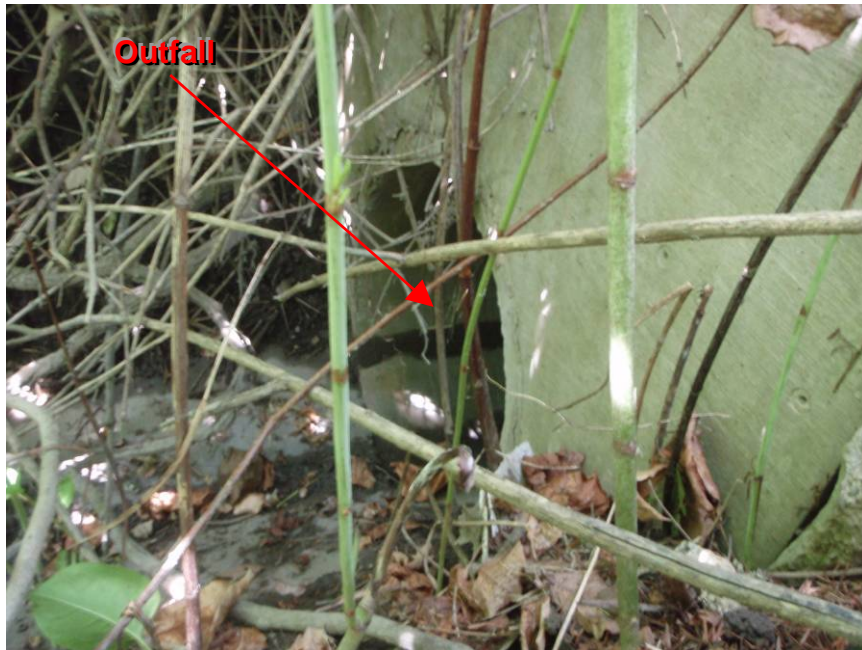
Photograph 10. Outfall Observation Location #3 – MS4 outfall to Paxton Creek at west end of Cumberland Street. The EPA Inspection Team and City staff were not able to locate another outfall at this location denoted on City's map.

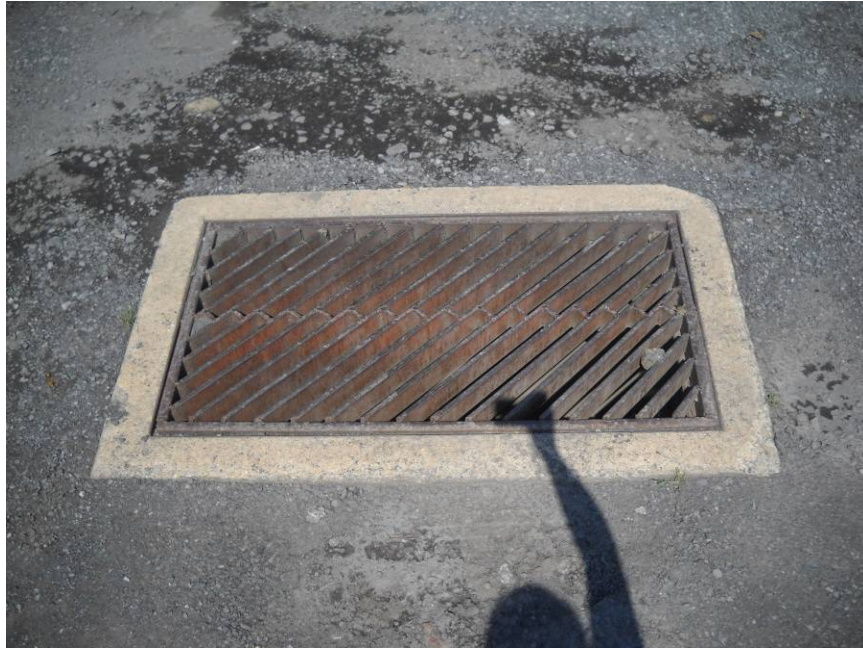
Photograph 11. Outfall Observation Location #4 – Storm drain inlet in a parking lot along west side of Paxton Creek between Cumberland Street and Herr Street.

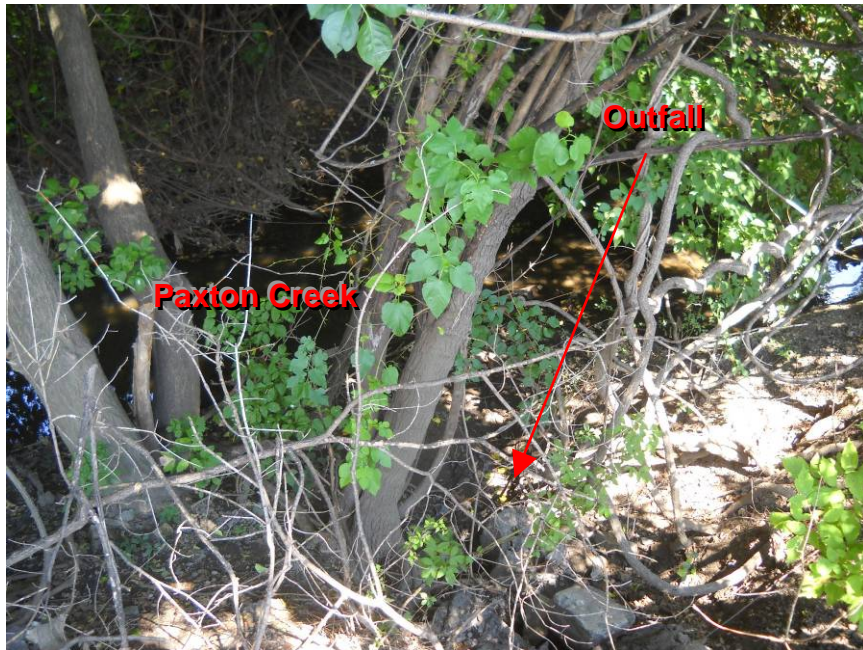
Photograph 12. Outfall Observation Location #4 – Storm drain outfall to Paxton Creek from inlet shown in Photograph 11.

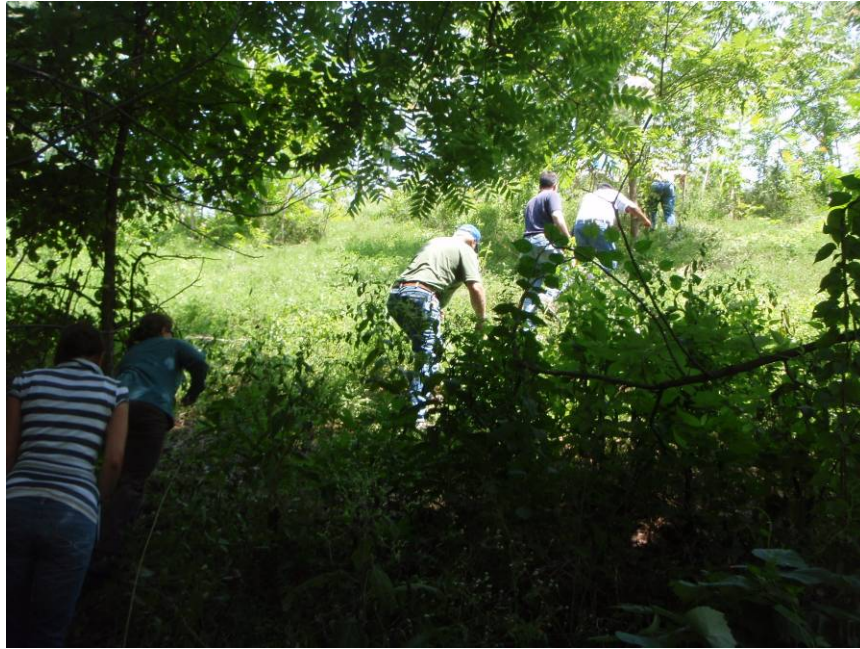
Photograph 13. Water Treatment Facility – Inspection Team members hiking up vegetated slope to access detention basin.

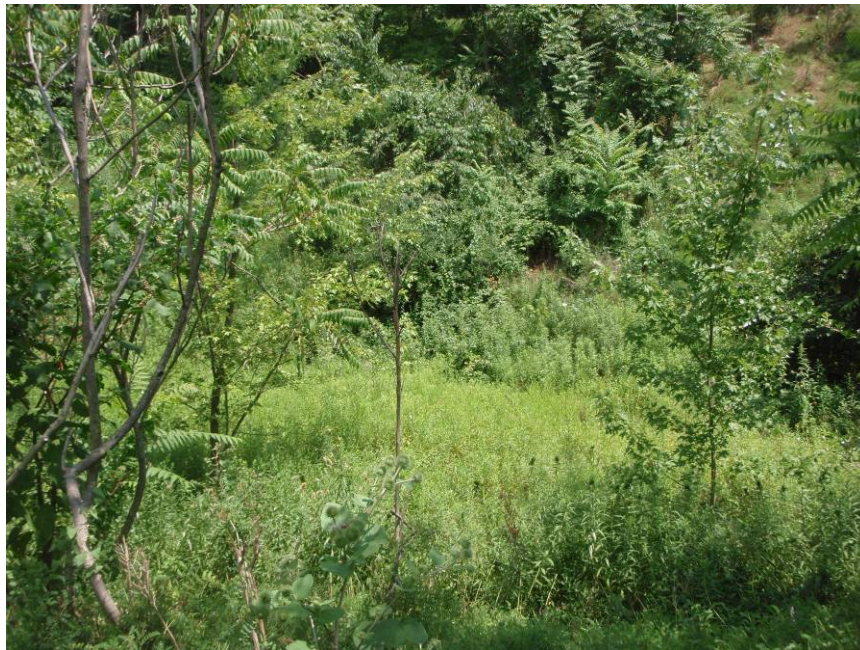
Photograph 14. Water Treatment Facility – View to northeast into detention basin at City's Water Treatment Facility. Note overgrown vegetation.

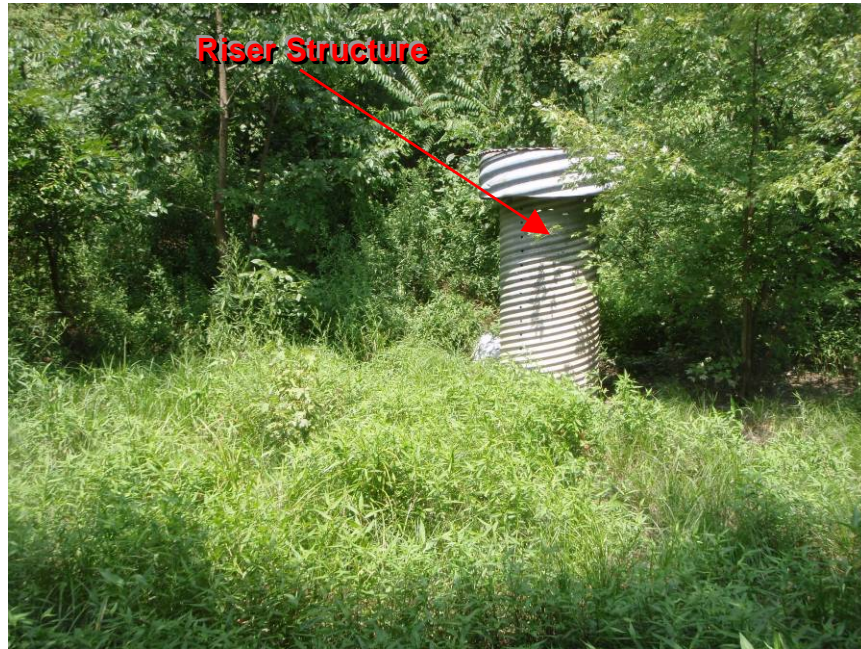
Photograph 15. Water Treatment Facility – View of riser structure in detention basin. Note overgrown vegetation.

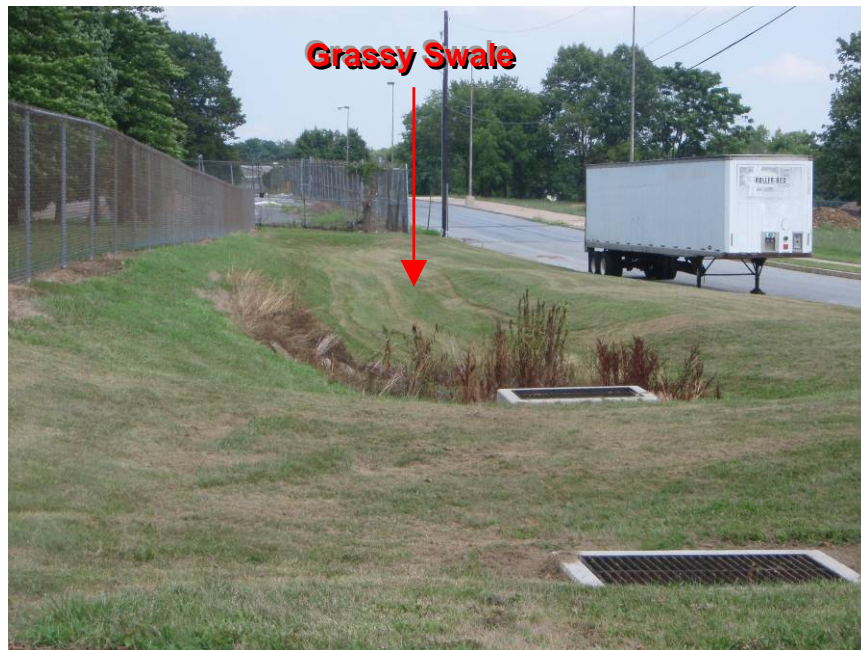
Photograph 16. Water Treatment Facility – View of grassy swale in northeast corner of intersection of Pine Drive and Stanley Road.

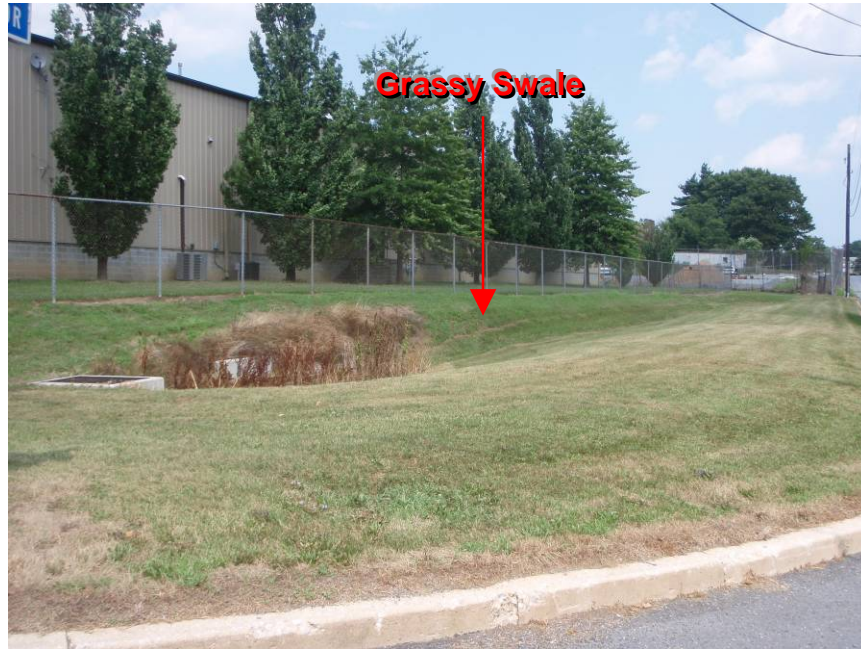
Photograph 17. **Water Treatment Facility – Another view of grassy swale shown in Photograph 16.**

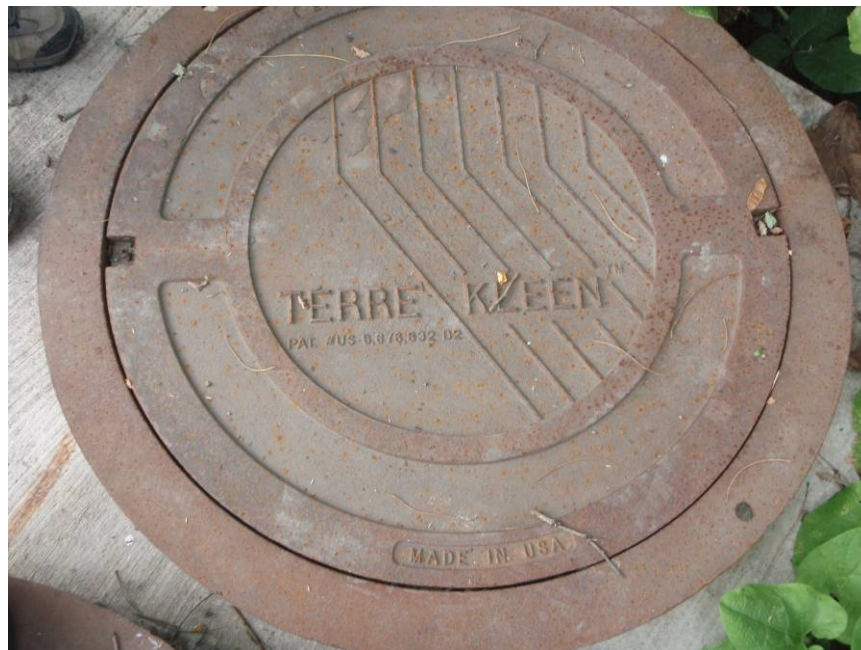
Photograph 18. **Public Works Facility – Access manhole for underground Terre Kleen stormwater control BMP in southwest portion of Public Works Facility.**

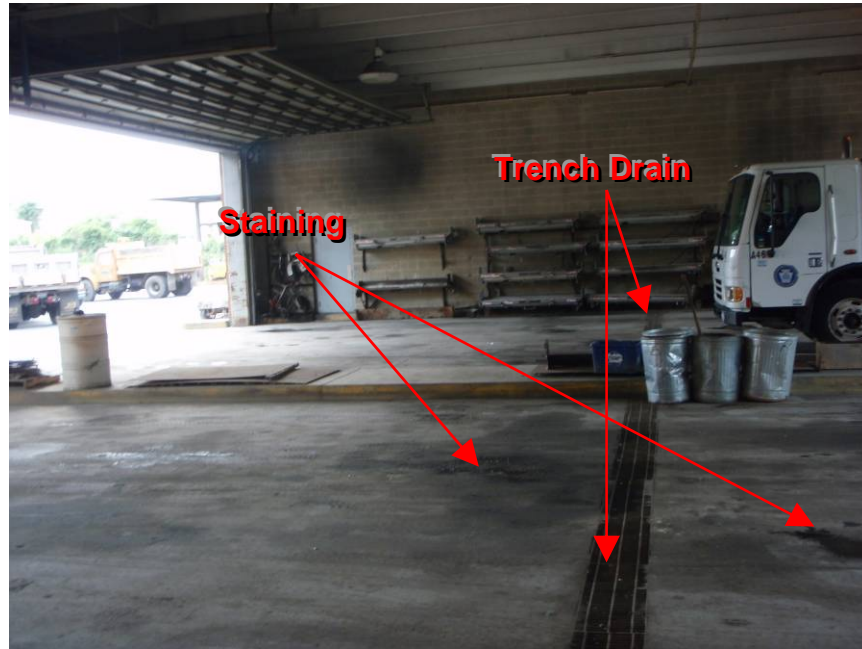
Photograph 19. Public Works Facility – View of staining on impervious ground surface adjacent to trench drain. Discharge location of trench drain was unknown.

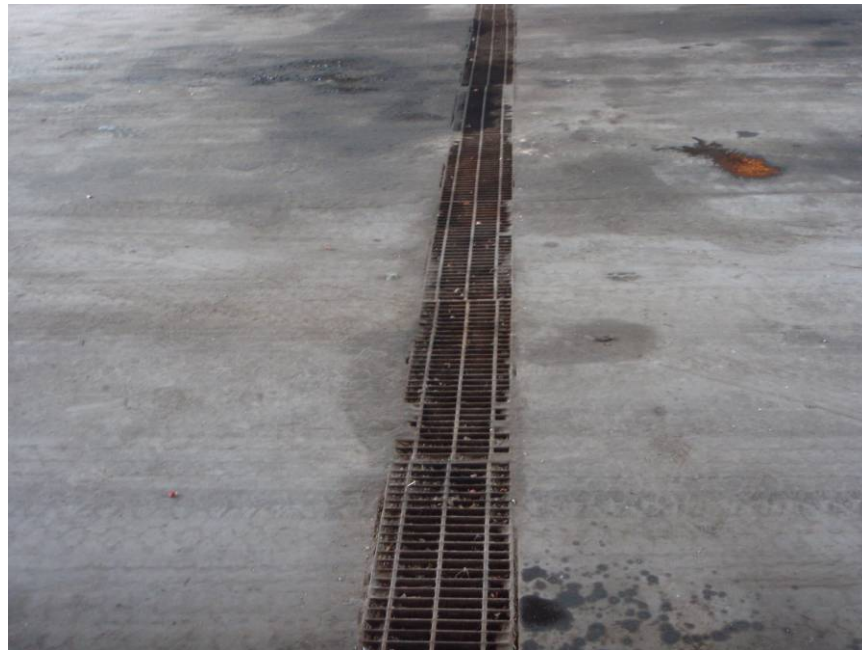
Photograph 20. Public Works Facility – Close-up view of trench drain shown in Photograph 19. Note staining and evidence of previous spills on impervious ground surface.

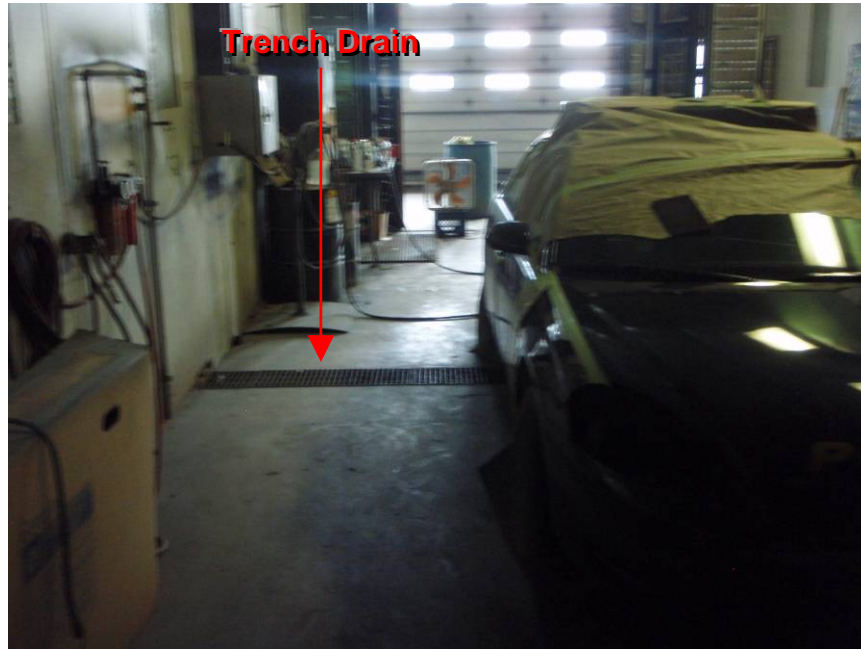
Photograph 21. **Public Works Facility – View of vehicle painting area in auto body shop.**

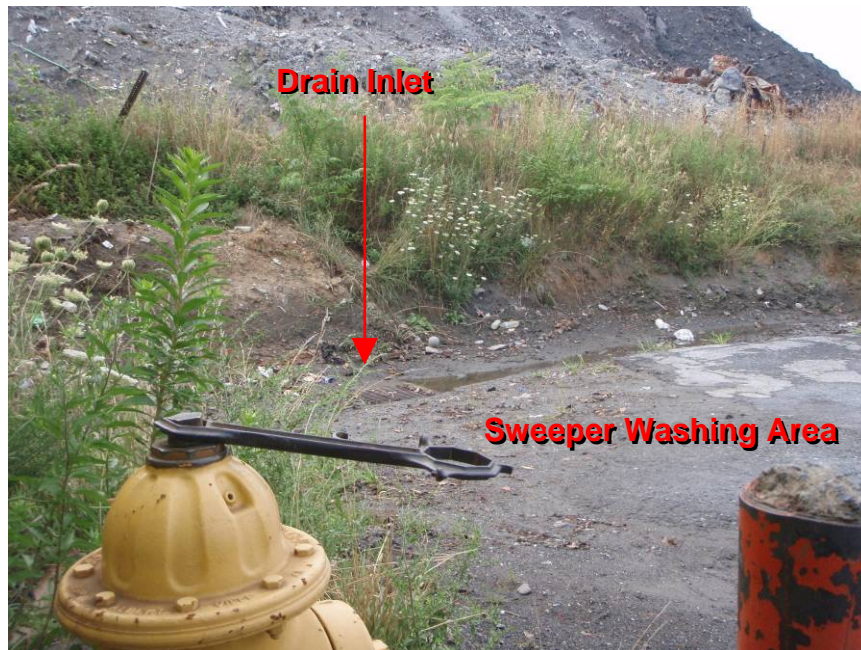
Photograph 22. **Public Works Facility – View of street sweeper washing area near southeast corner of street maintenance building.**

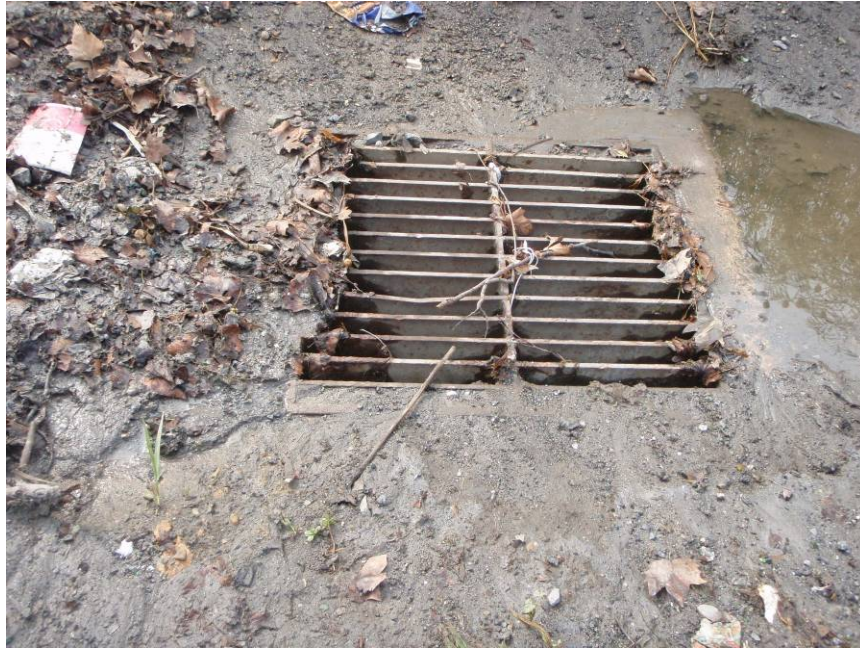
Photograph 23. Public Works Facility – Close-up view of drain inlet shown in Photograph 22. Note sediment and debris accumulation surrounding inlet.

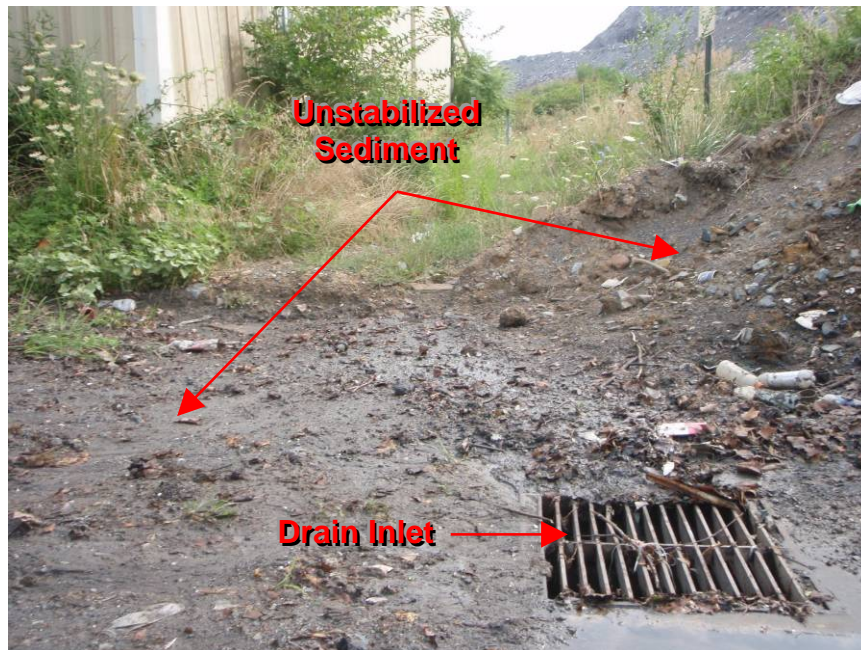
Photograph 24. Public Works Facility – Additional view of drain inlet shown in Photographs 22 and 23. Note unstabilized sediment adjacent to drain inlet.

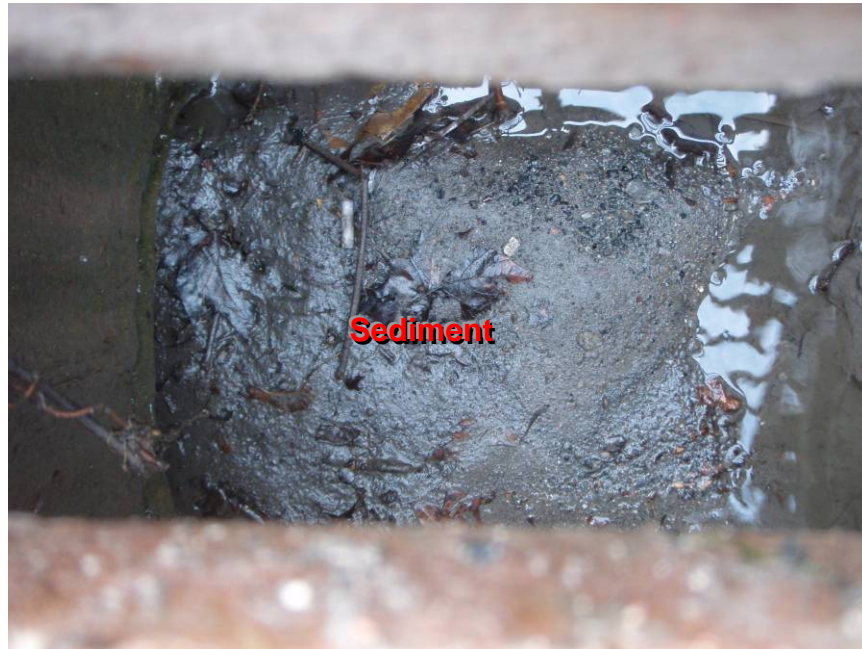
Photograph 25. Public Works Facility – View into drain inlet shown in Photographs 22–24. Note sediment in drain inlet.

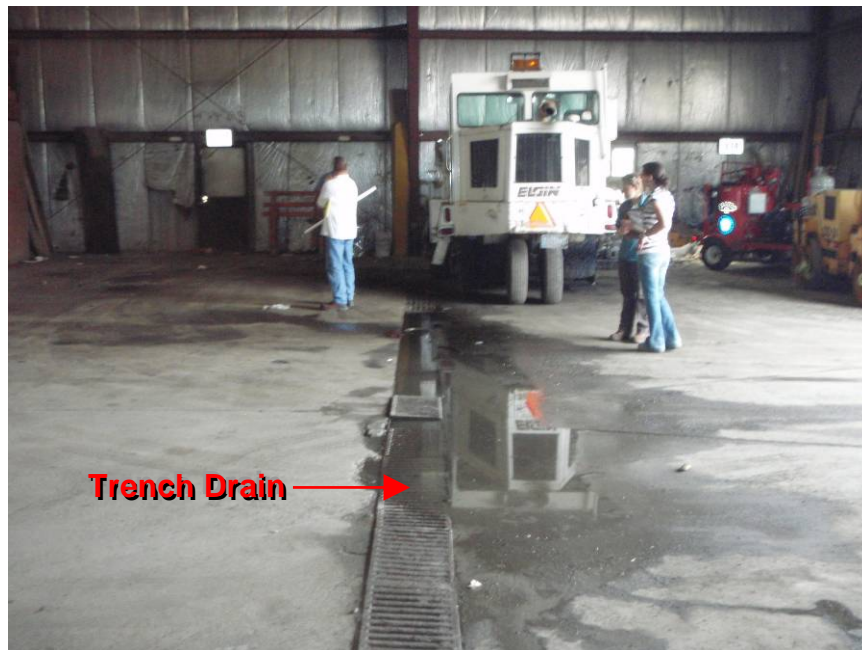
Photograph 26. Public Works Facility – View of vehicle washing area adjacent to trench drain in street maintenance building.

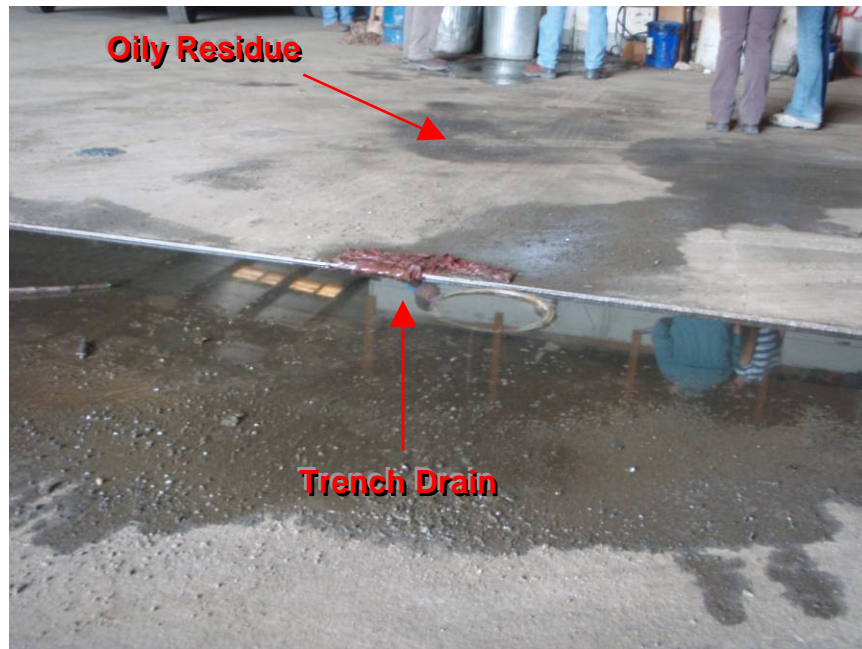
Photograph 27. Public Works Facility – Close-up view of trench drain shown in Photograph 26. Note oily residue near trench drain and standing water, indicating that trench drain was not functioning properly.

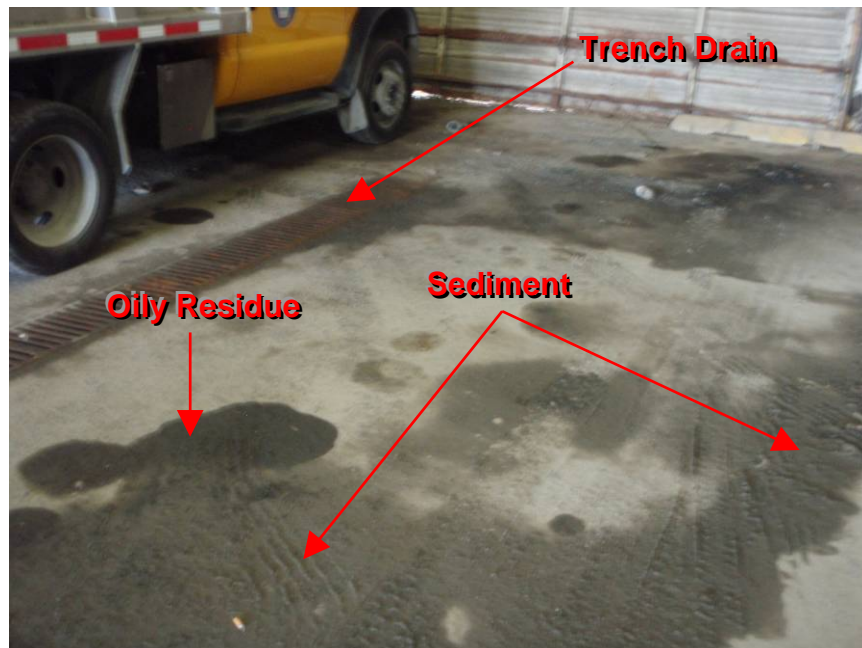
Photograph 28. Public Works Facility – Oily residue and sediment accumulation on floor surface adjacent to trench drain.

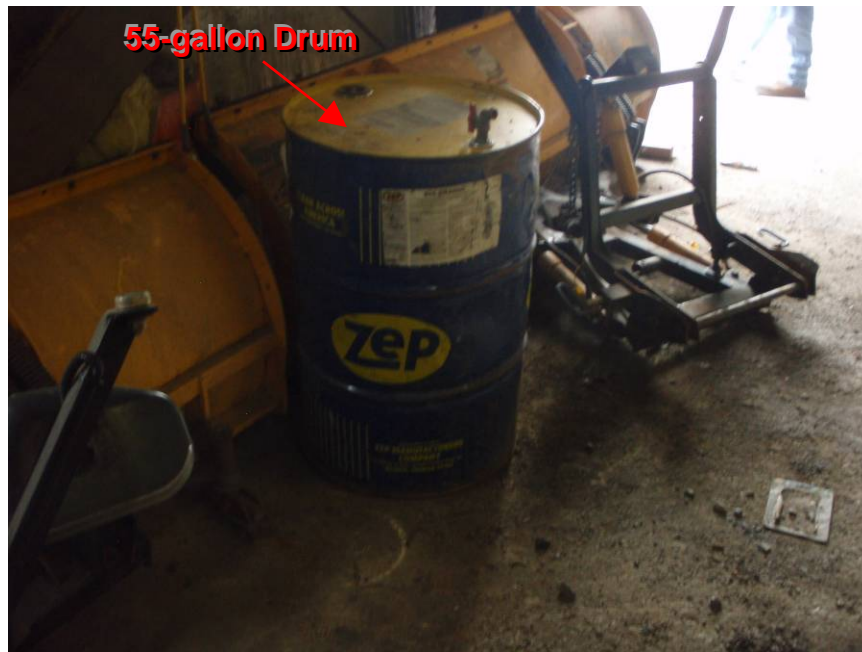
Photograph 29. Public Works Facility – 55-gallon drum of degreaser stored without secondary containment upgradient of trench drain.

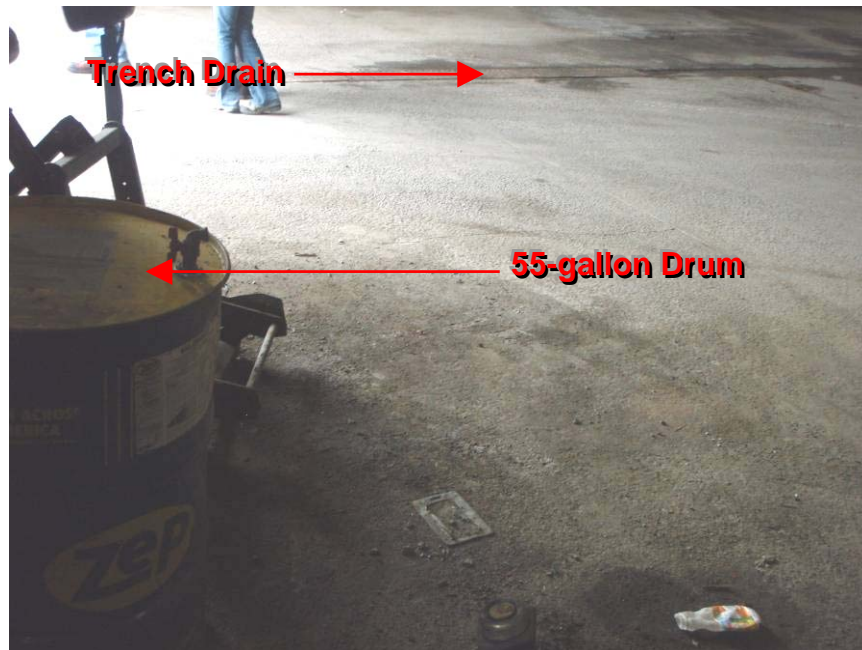
Photograph 30. Public Works Facility – View toward trench drain from 55-gallon drum shown in Photograph 29.

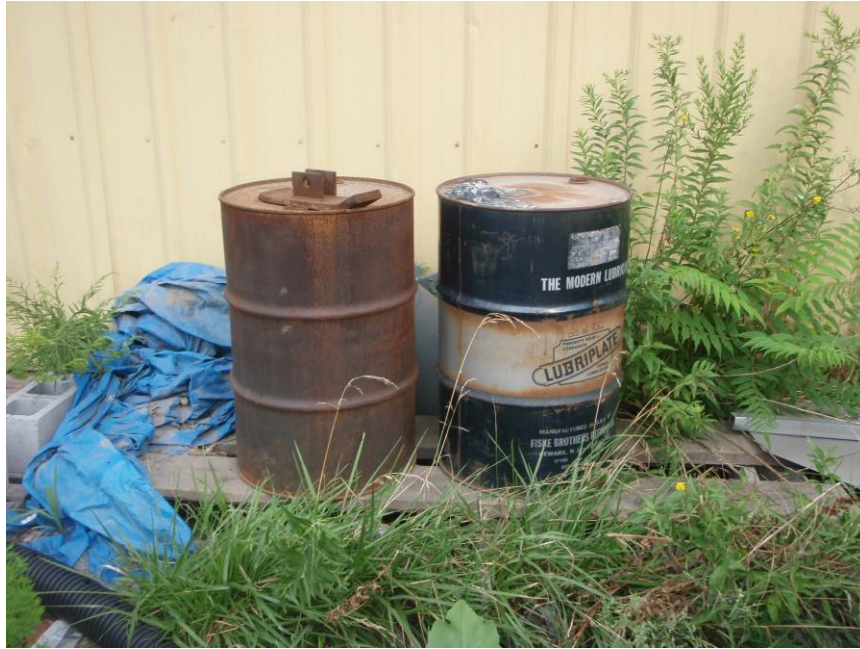
Photograph 31. Public Works Facility – Unlabeled 55-gallon drums of fluid stored outside without cover or containment upgradient of drain inlet shown in Photographs 35 and 36.

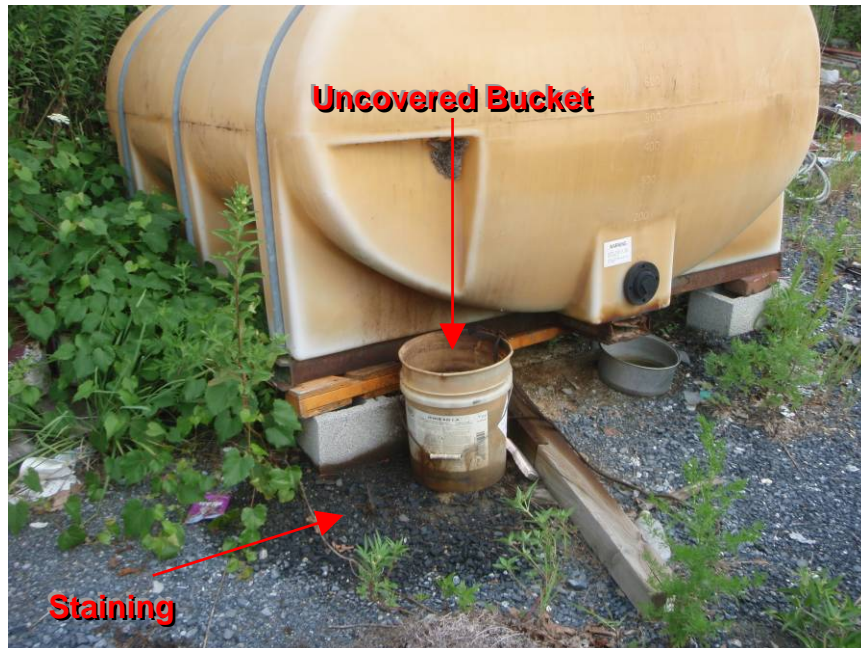
Photograph 32. Public Works Facility – Open bucket containing an unknown fluid with an oily sheen. Note staining on ground surface adjacent to bucket.

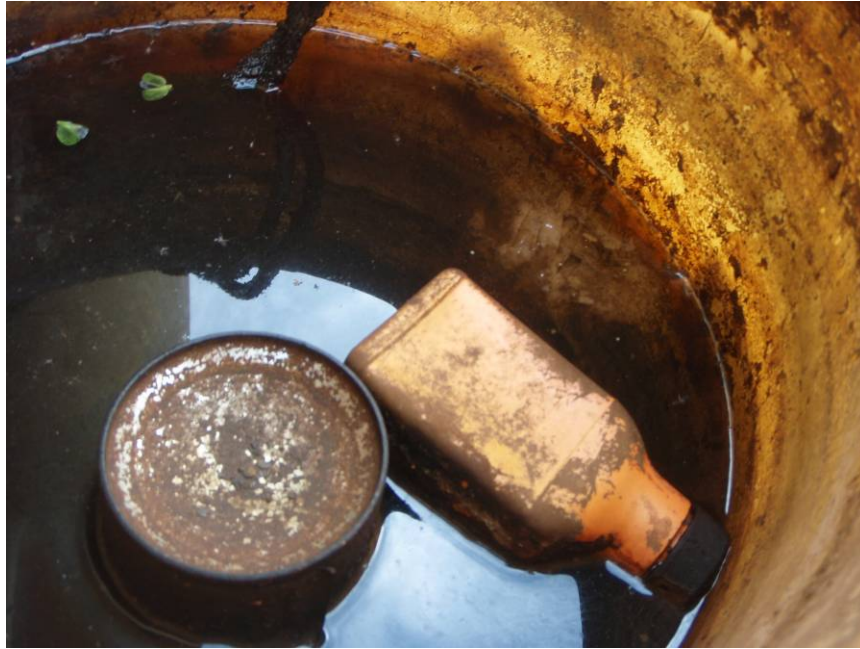
Photograph 33. **Public Works Facility – View inside bucket shown in Photograph 32.**
Note oily sheen.

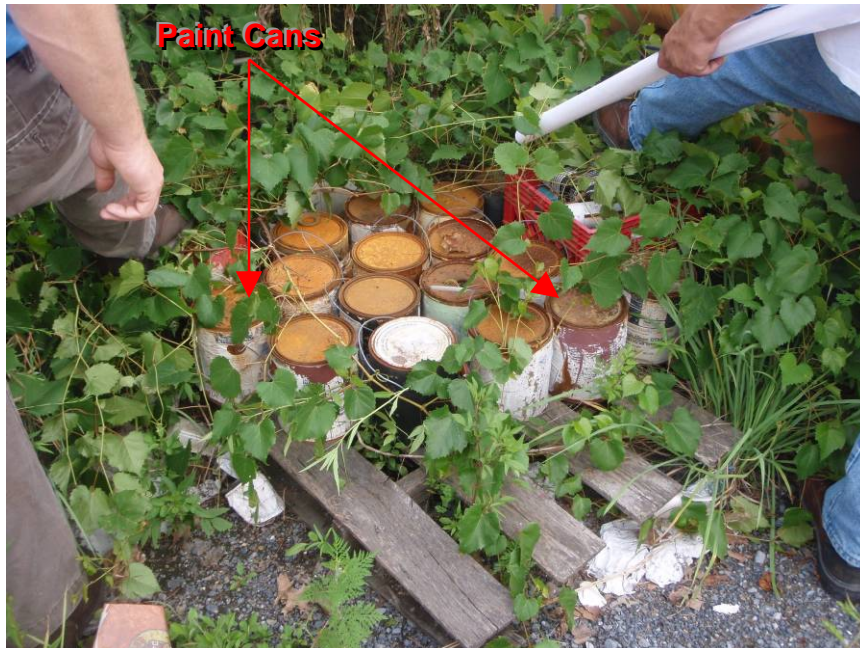
Photograph 34. **Public Works Facility – Unlabeled cans, which appeared to contain paint, stored without cover or containment near street maintenance building.**

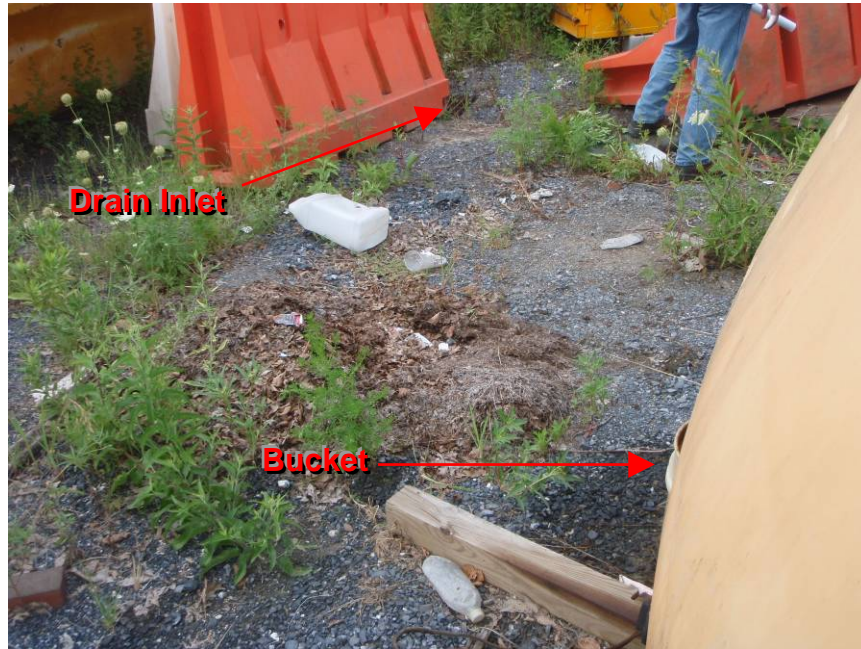
Photograph 35. Public Works Facility – View from bucket shown in Photographs 32 and 33 toward drain inlet.

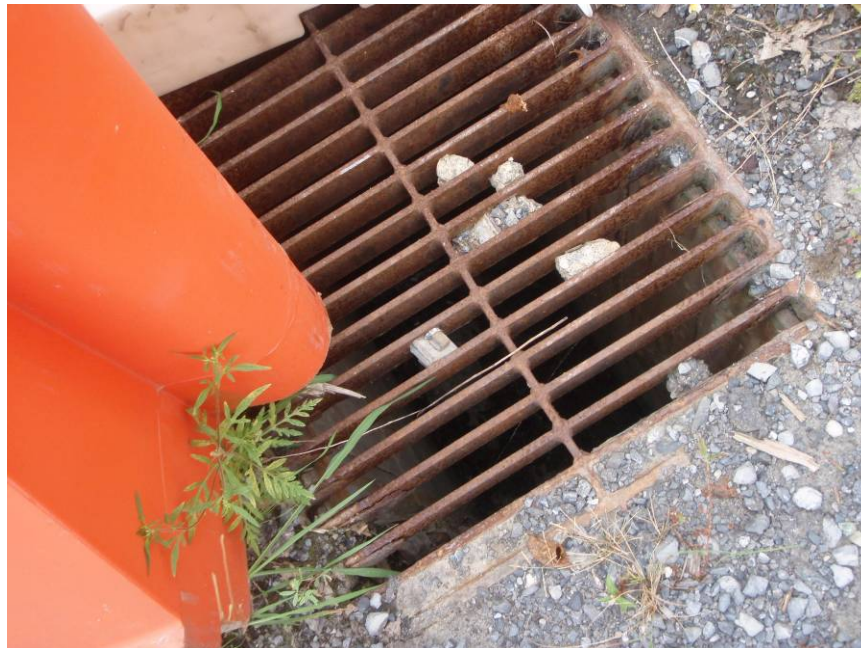
Photograph 36. Public Works Facility – View of drain inlet shown in Photograph 35.

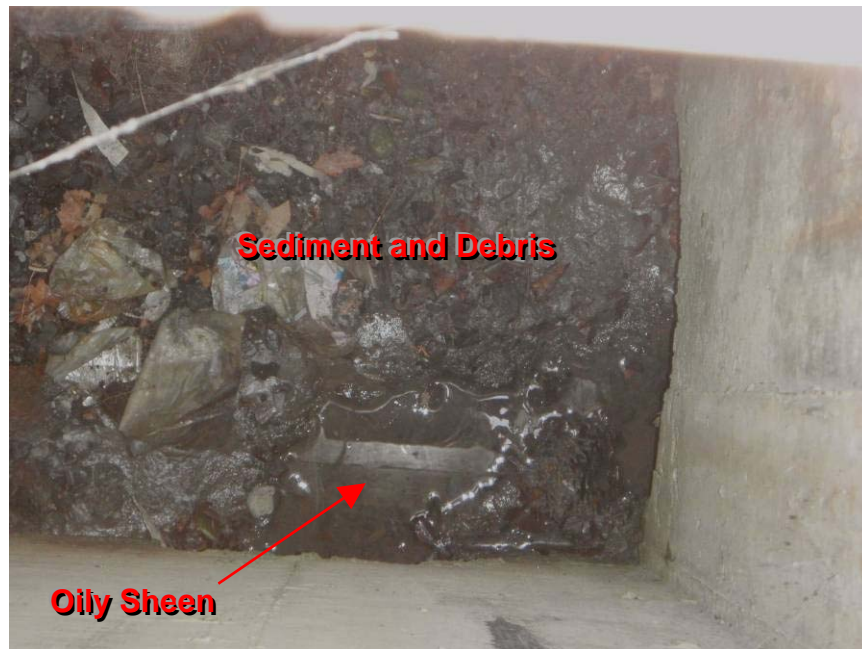
Photograph 37. Public Works Facility – View into drain inlet shown in Photographs 35 and 36. Note sediment, debris and oily sheen.

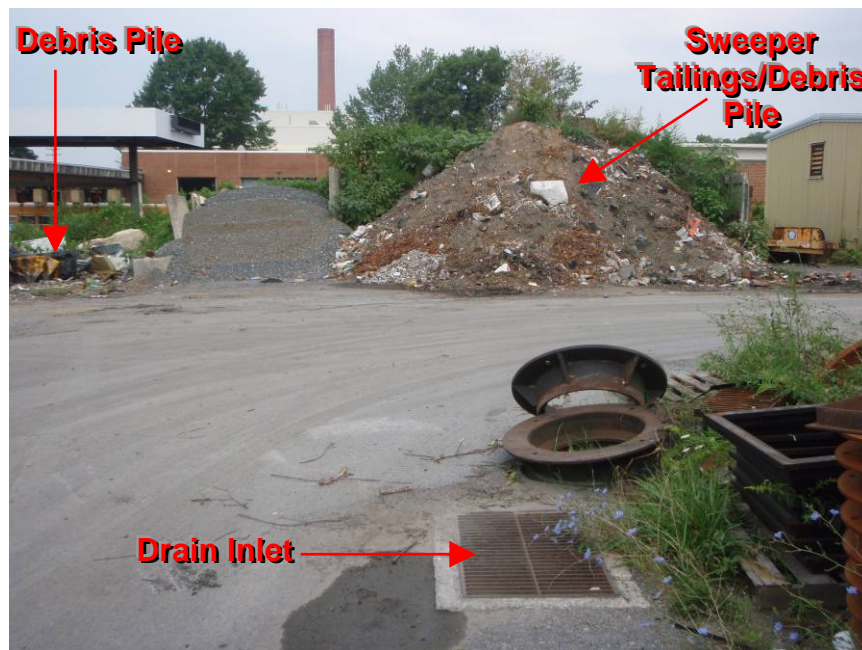
Photograph 38. Public Works Facility – Sweeper tailings and debris piles upgradient of drain inlet adjacent to street maintenance building.

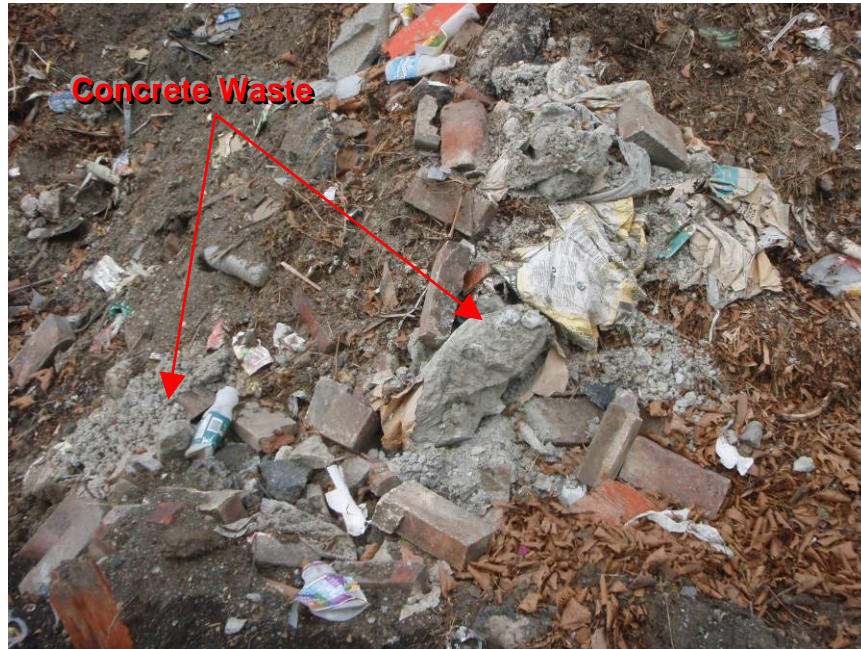
Photograph 39. Public Works Facility – Close-up of concrete waste in sweeper tailings/debris pile shown in Photograph 38.
